Washington State
School Seismic Safety Assessments Project

MORTON ELEMENTARY SCHOOL MAIN BUILDING Morton School District

SEISMIC UPGRADES CONCEPT DESIGN REPORT

June 2021

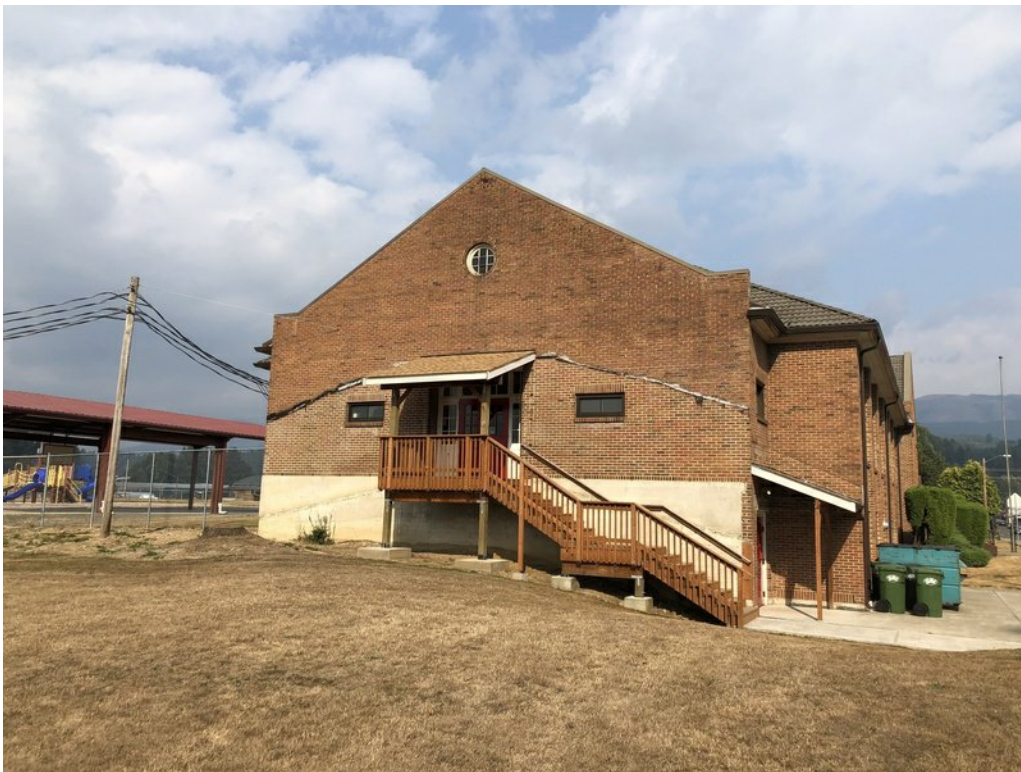
Figure 1-2. Morton Elementary School - West Exterior

Structural System	Description
Structural Roof	No visible signs of corrosion, damage, or deterioration.
Structural Floor(s)	No visible signs of corrosion, damage, or deterioration.
Foundations	Unknown, not visible.
Gravity System	Cracking observed on interior wall at stairwell. Cracking of brick veneer along west exterior wall.
Lateral System	No visible signs of corrosion, damage, or deterioration.
